## **SERVICE BULLETIN**

SB-195 A

8 Bondline Inspection

AA-5A, AA-5B AA5, AA1, AA-1A, AA-1B and AA-1C

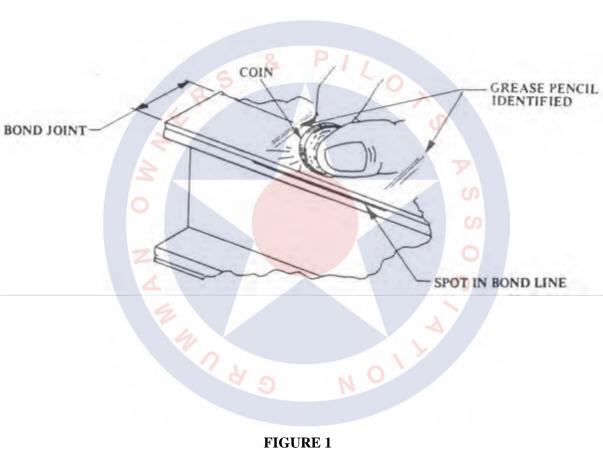
FIGURE 1 TAP TEST

- 1. Carefully inspect all bondlines of the wings, stabilizers and fuselage (Figure 2 & 3) for bondline separation using the "Tap Test" method. With a coin or similar object, tap the length of each bondline while listening for a change in tone as the area is traversed. A bondline separation will produce a flat or hollow sound when tapped in the delaminated area. Mark delaminated areas with a grease pencil on the outer surface. (Figure 1)

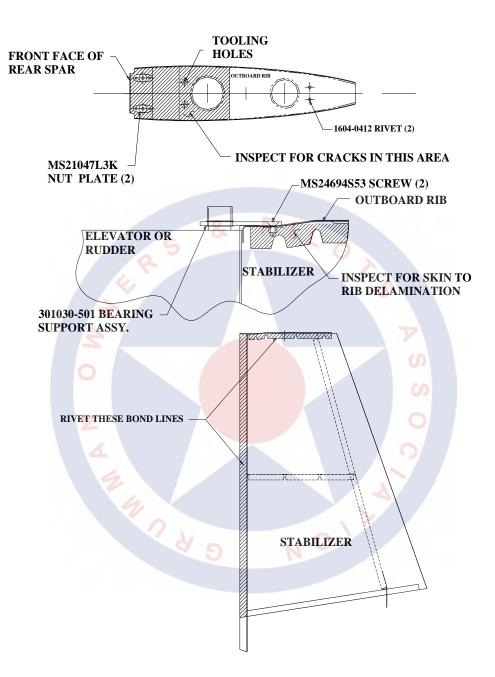
- 1. Inspect all bondlines of the horizontal stabilizers as called out in A, 1-4 above (FIGURE 3) with emphasis on the outboard rib at the outboard elevator bearing support assembly (FIGURE 4).
  - a. Remove the outboard bearing support assembly from the outboard rib of each stabilizer. Ref: AA1 or AA5 Series Maintenance Manual Chapter 55.
  - b. Inspect the outboard rib in the shaded area for cracks, buckles, corrosion and delamination (FIGURE 4).

- c. Inspect the two MS210471L3K nut plates for security and condition. Replace if corroded or rusty.
- d. If no damage is found, remove paint and surface corrosion from the rib, clean with acetone and repaint. Make sure paint covers the bondlines.
- e. Reinstall the bearing support using new MS24694S53 screws.
- 2. If any delamination or a previous repair is found on either horizontal stabilizer, accomplish the following.
  - a. Remove the elevator and the stabilizer as required to gain access to the affected bond joints. Ref: AA1 or AA5 Series Maintenance Manual Chapter 55.
  - b. Repair delaminated bond joints in accordance with instructions in SK-125B, D-1 and D-2.
  - c. To protect the integrity of the 301030-501 bearing support assembly attach point, install rivets in accordance with SK-125B, D-1 in the top and bottom of the outboard rib and rear spar bondlines (Figure 4).

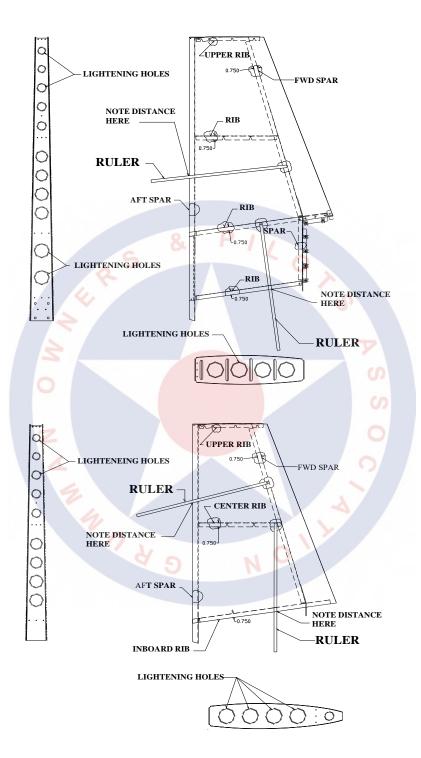
FIGURE 5 SAMPLE RULER LOCATIONS, HORIZONTAL AND VERTICAL STABILIZERS

See Figure 5 for rib and spar flange center line location. When the rivet pattern has been established, visually verify that proper distance from the edges of the flange is maintained as each hole is drilled. Hole pattern may need to be modified.

A rigid ruler or other suitable measuring device may be used as an aid for locating the flanges of the center rib and forward spar. Reference Figure 5.

- i. To locate the forward spar flange, insert a ruler into a lightening hole in the rear spar of the stabilizer until it contacts the forward spar web. Make sure the end of the ruler is resting solidly against the spar web and not on a spar lightening hole flange and, as close to perpendicular to the spar as possible. Note the distance from the stabilizer trailing edge to the spar web. Remove the ruler and on the outer surface of the stabilizer (at the same location), measure that distance from the stabilizer trailing edge forward and mark the location of the spar web. Repeat this process as necessary along the spar to establish a line indicating the forward spar flange location. Mark rivet lines in accordance with SK-125B Figure 3.

- ii. To locate the stabilizer center rib flange, insert a ruler into a lightening hole in the inboard end of the stabilizer until it contacts the forward rib. Make sure the end of the ruler is resting solidly against the rib web and not on a lightening hole flange and, as close to perpendicular to the rib as possible. Note the distance from the stabilizer inboard edge to the rib web. Remove the ruler and on the outer surface of the stabilizer (at the same location), measure that distance from the stabilizer inboard edge outward and mark the location of the rib web. Repeat this process as necessary along the rib to establish a line indicating the center rib inboard flange location. Mark rivet lines in accordance with SK-125B Figure 3.

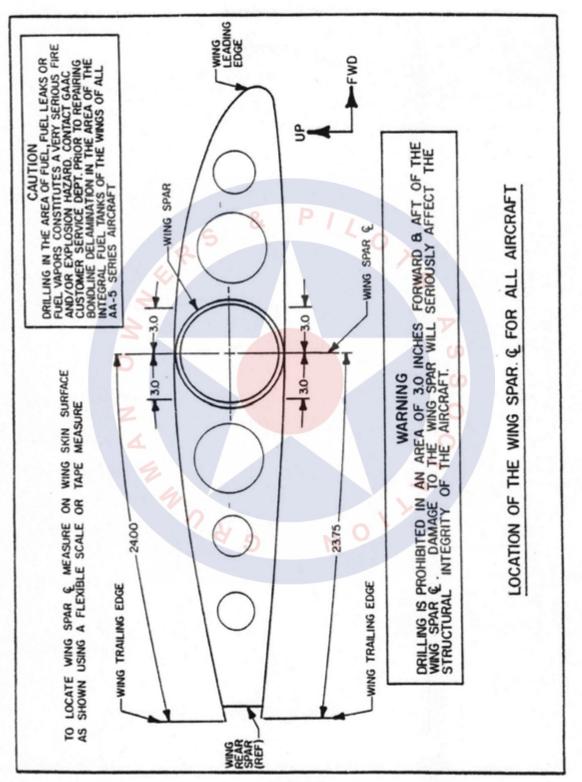
FIGURE 2

Exercise extreme care drilling in the wing. Drilling is prohibited in an area of 3.0 inches on either side of the centerline of the wing spar. See Figure 2 or dimensions necessary for locating wing spar centerline
